## **BURNED-AREA REPORT**

A. Fire Name: Wash Fire B. Fire Number: ID-NCF-000881

E. Region: <u>01</u> F. Forest: <u>Nez Perce-Clearwater</u>

G. District: Moose Creek RD H. Fire Incident Job Code: P1J17M

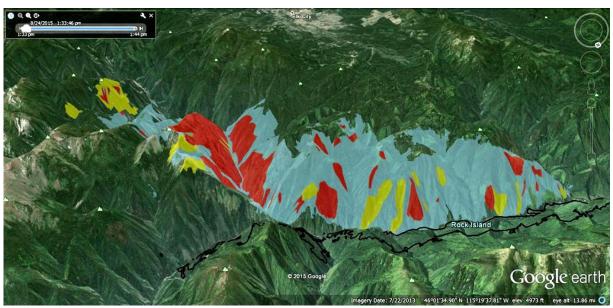
A. **Burn Severity** (acres): <u>21,934</u> (low) <u>4,279</u> (moderate) <u>8,109</u> (high)

Google Earth Image of the Wash fire area from the north looking south with the preliminary burn severity ratings shown.
